Characterization of the “Waru Waru” soils on the Peruvian high plateau

Sandro Sardon Nina^{1*}, Juan Carlos Loaiza-Usuga², Diego Varga³, Yoissy Pari Morales⁴

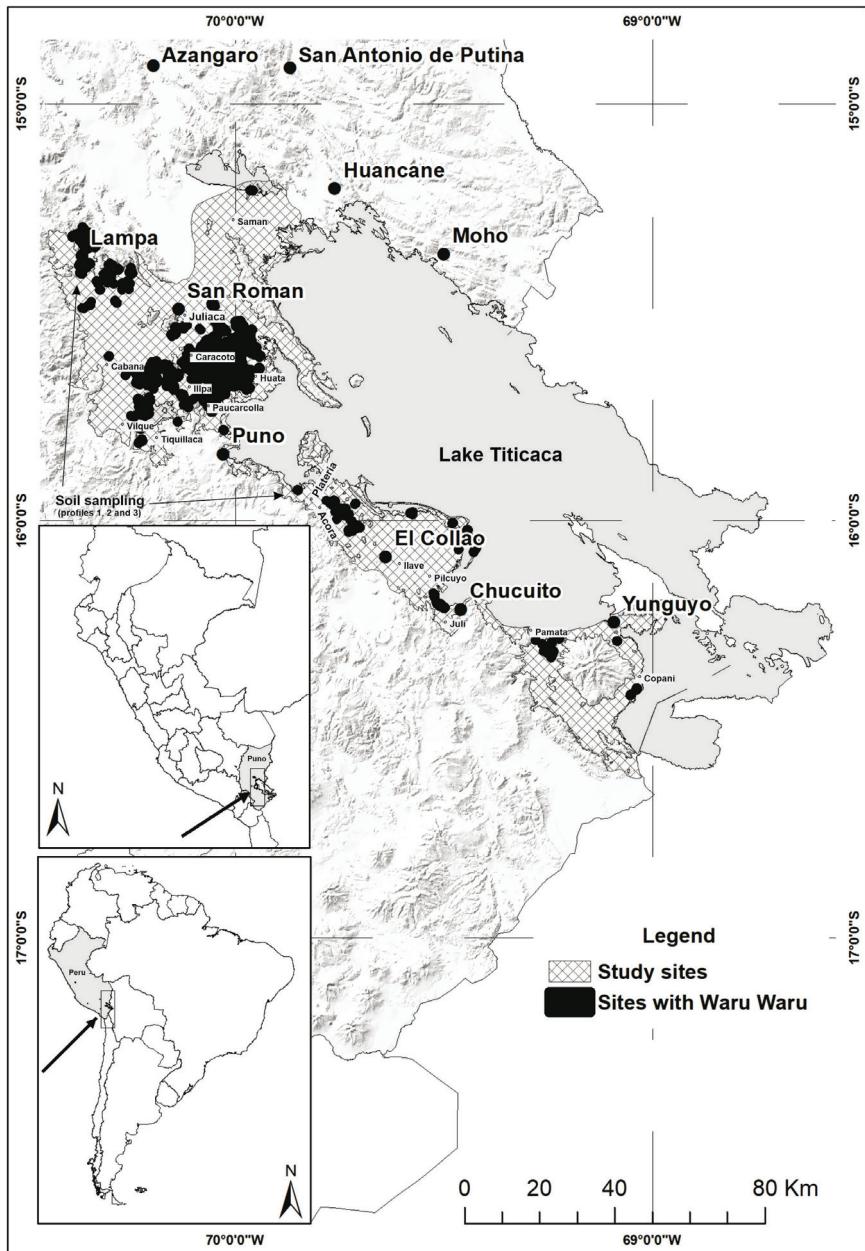
Fig. 1. Total area of the study site and spatial distribution of Waru Waru systems.

Waru Waru systems are located in the Yunguyo, Chucuito, El Collao, Puno, San Román, Lampa, Azángaro, and Huancané provinces in the department of Puno, Peru (Fig. 1) and covers an area of 3,899 ha (Table 1). Ridge systems distribution was de-

al systems around Lake Titicaca, to an area of just 3899 ha. In other regions, high population density and land parceling (land pressure) deteriorated the Waru Waru systems due to the introduction of mechanization through intensive agricultural systems. Fig. 1 presents the distribution of the Waru Waru systems around Lake Titicaca.

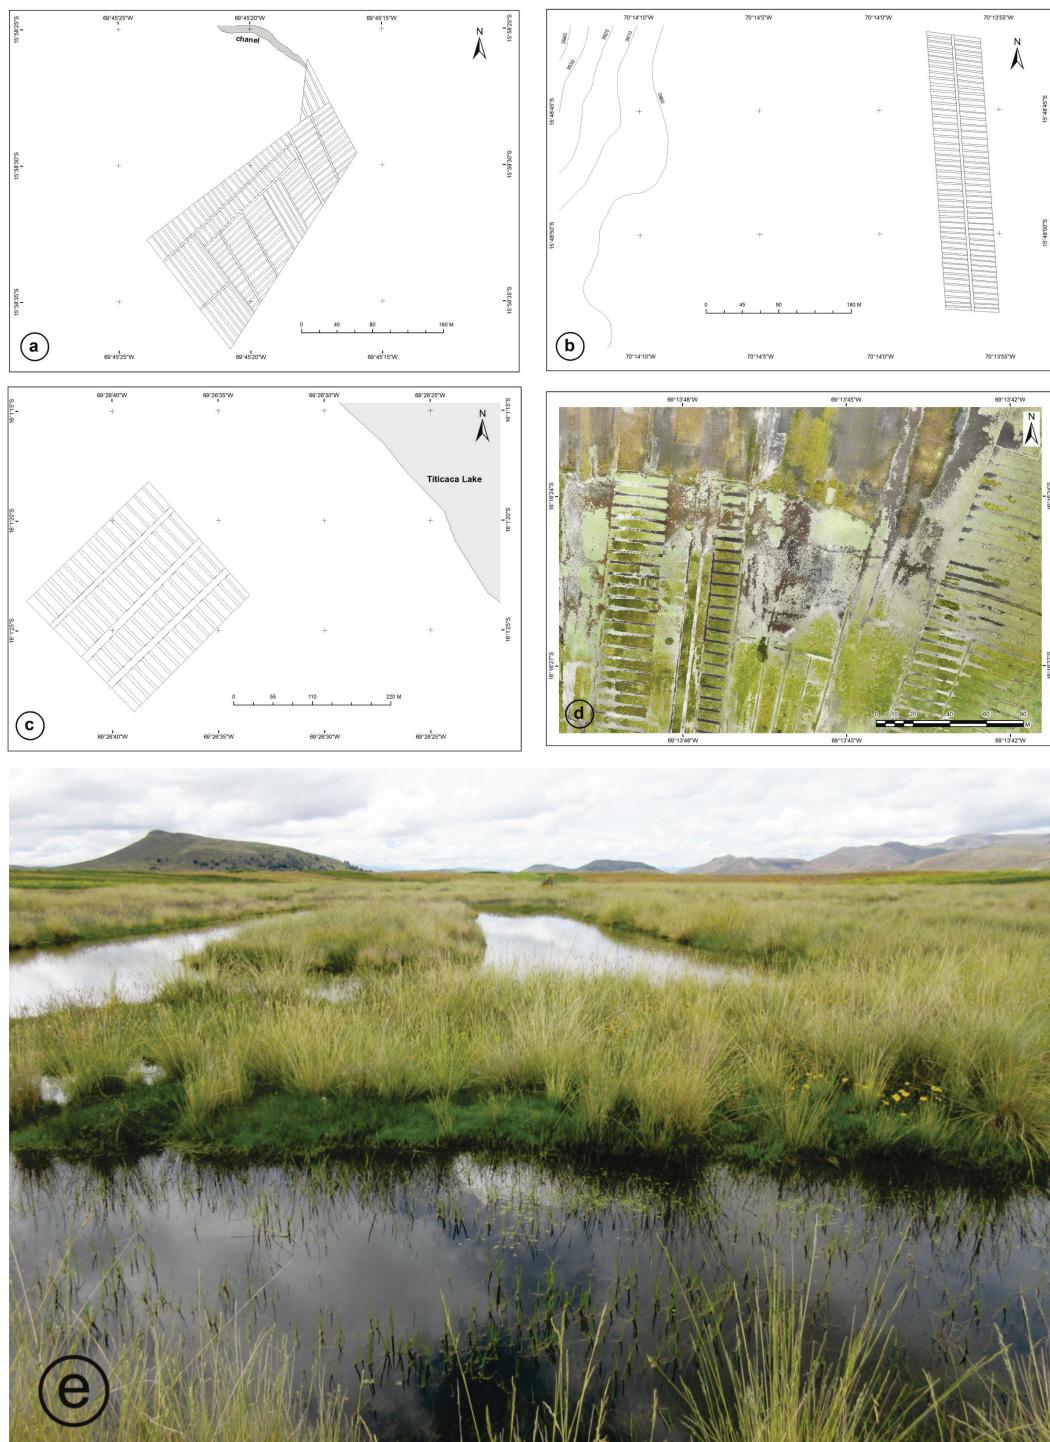
Fig. 2. The Waru Waru system examples. a. Fluvial system, b. Pluvial system, c. Phreatic system, d. Wave image of phreatic system acquired from a drone in the town of Chatuma, district of Pomata.

termined according to PIWA (1994) methodology and is shown in Table 3. The maximum distance of Waru Waru systems to the lake is 50 km, and the mean slope is < 2%, which favored an efficient water use and runoff, flood and phreatic water control. The fluvial system covers 14.5% of the study area, and its source are the rivers Coata, Lampa, Cabanillas, Illpa and Río Grande. The water is supplied to the Waru Waru system through the inlet and outlet channels that are regulated through dams constructed for the storage of water within the channels (Fig. 2a). The pluvial system covers 70.2% of the study area and uses rainwater accumulation at the foot of the slopes and is designed to collect water from the slopes or mountains, while in certain cases this system uses the drainage network (Fig. 2b). The phreatic systems, which covers 15.3% of the study area, are located on the shores of the lake and surrounding lagoons and are subjected to groundwater table seasonal variations and floods occurrence (Fig. 2c and 2d).

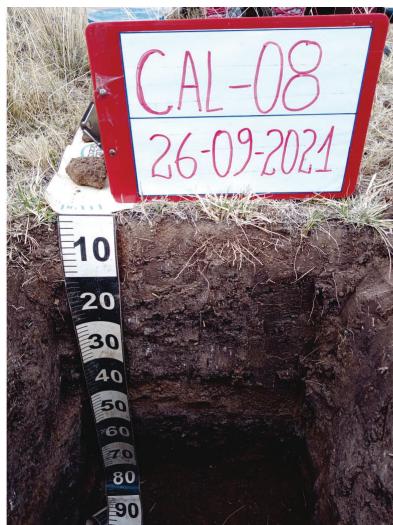
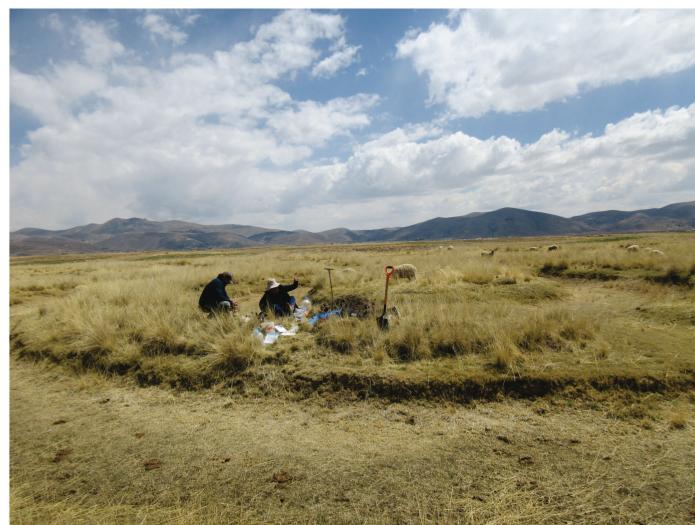
Profile 1. Phreatic system: Eutric Fluvic Stagnosol (Epiabruptic, Aric, Cambic, Capillaric, Drainic, Ochric, Transportic)

Fig. 3. Anthropic soil profiles in the Waru Waru systems.

tic). Fig. 3 shows the soil profiles and landscape studied in the present research. These soils had loam to sandy-loam textures and were a product of low-energy fluvial sedimentation. Similar results were reported by Boixadera et al. (2019) for hydromorphic soils in the Llanos de Moxos – Bolivia. Ap horizons < 20 cm in thickness have a higher organic matter content, granular structure, and abundant root channels. The subsurface Bw horizons have a thickness between 20 and 40 cm and a subangular blocky structure. The boundaries between the horizons are clear and smooth. All horizons of the soil profile up to 60 cm or 80 cm in depth, which have good structure and presence of root channels (Table 4). These structures had a maximum thickness of 80 cm and tended to be sandy toward the base with a gravel content of 5% to 10%, which facilitated drainage. Certain horizons present stagnic properties at depth, which were associated with seasonal oxidation-reduction and palaeohydrological processes. According to Boixadera et al. (2019), epi-saturation was responsible for the presence of redoximorphic features. Ridge (Waru Waru) structures assist in resolving both permanent and seasonal problems of water excess in the marshes and water management during drought and flood periods (Caivallet, 2008). The bulk density was low in Ap horizons due to its higher organic matter content and root activity. Bulk density increased slightly with depth, although with no evidence of deterioration due to soil compaction (USDA, 2001). The soil profile 1 comprised a slightly saline in-depth horizon (Bw3) due to the leaching of ions during rainy periods. The alkalinity values in Lake Titicaca are high (75–150 mg/l) and very high (> 150 mg/l), the content of carbonates and bicarbonates is high (Betran et al., 2015); favors the entry of salts in the soil profile from groundwater in phreatic Waru Waru systems, and in soils near the lake. The Ap horizons were strongly acidic to slightly alkaline. The presence of salts on the surface is associated with the use of irrigation water, and in flooding areas with drainage limitations (OEA, 1996). The pH conditions favor the availability of nutrients and the action of bacteria and actinomycetes (USDA, 2001), with good conditions for plant growth (Table 5). The presence of carbonates was not evident, the pH varied highly between the horizons in the same soil profile, with a tendency to be moderately acidic. Two horizons in profile 2 and profile 3 were strongly acidic, which was attributed to the nature of the parent material, which was siliceous. Merdy et al. (2022) reported that changes in the alkaline nature of wetlands could rapidly disappear upon altering the drainage conditions. The reworked materials from sandstones, red limestone, and conglomerates (Rodriguez et al., 2020) in lacustrine conditions favor the development of moderate to slightly acidic soils (Merry et al., 2022).

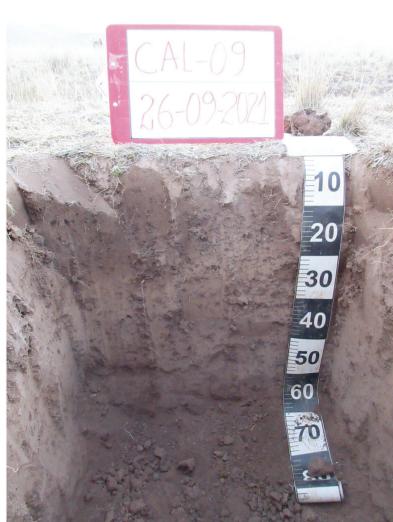
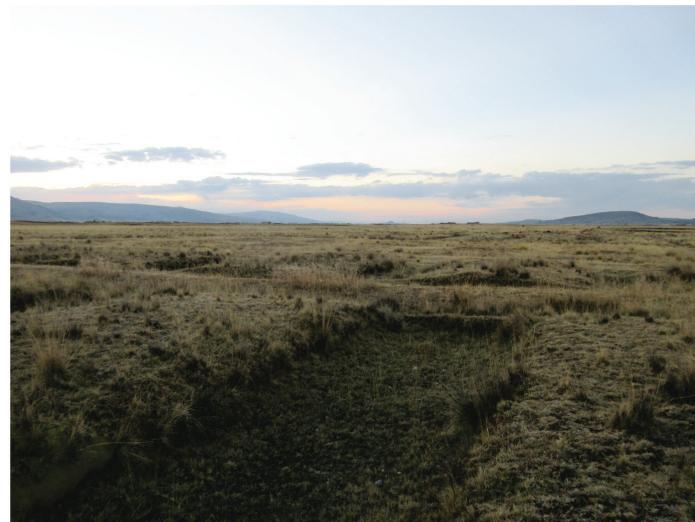
Profile 2. Fluvial system: Eutric Fluvic Cambisol (Aric, Drainic, Ochric, Transportic)

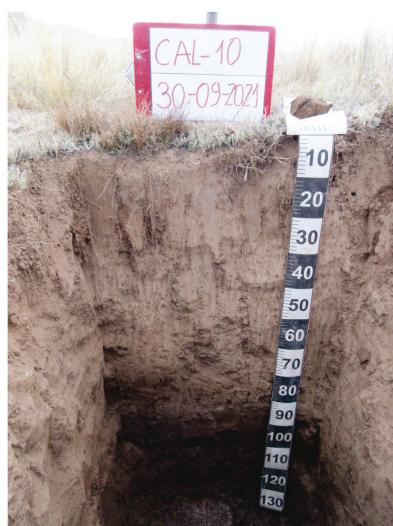
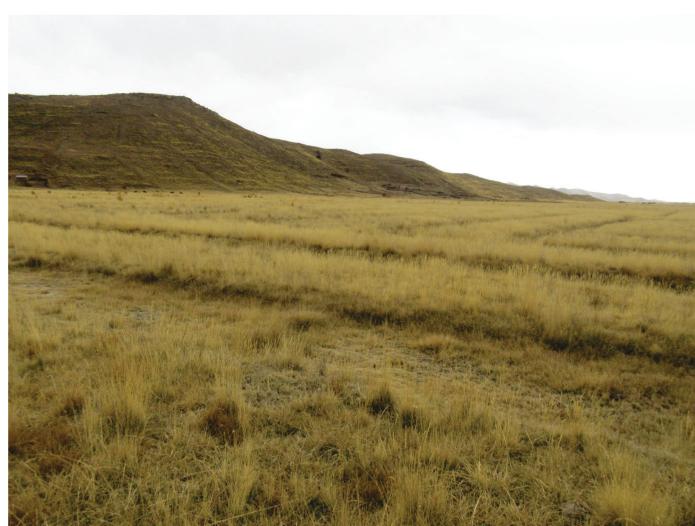
Profile 3. pluvial system: Cambic Fluvic, Stagnic Phaeozem (Pachic, Transportic)

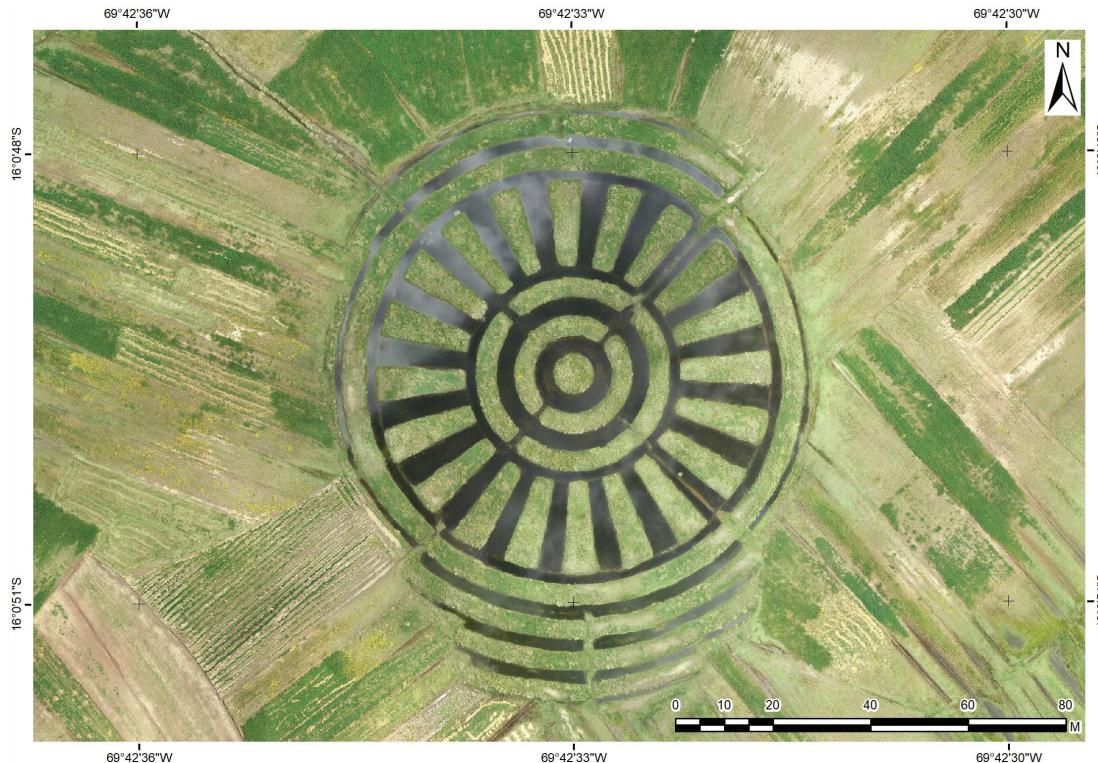
Fig. 4. Waru Waru system with a solar disk with irradiance shape.

A high percentage of Waru Waru structures used in the traditional agricultural regions (99.44%) have been transformed into grasslands or croplands using tractors. A transformation of the ridge areas into natural pastures began during Spanish colonization and was intensified during the 1960s with the introduction of agricultural cooperatives. This effect has been intensified in recent years due to land abandonment (migration of young people to the cities), drought, and the introduction of machinery (PIWA, 1992). These dynamics together favored the establishment of extensive cattle farms and land abandonment, thereby affecting the percentage of ridge lands. Currently, Waru Waru structures have varied dimensions for channel width, as well as different spacing between channels, ridge height, and fill height, with an east-west and north-south orientation. The distribution patterns, despite being varied and difficult to classify, follow the drainage network. Authors such as Smith et al. (1968), Earls et al. (1986) and Gondard, 2008 have reported approaches to pattern the classification of Waru Waru systems. Recent international projects have attempted to bring back the traditional Waru Waru systems for regenerative agriculture, for which solar disc shape structures have been introduced in the Acora and Illpa communities (Fig. 4).
